Mucky Marsh Mitigation Site (LRB-2019-00976)

Prepared by:
Ducks Unlimited Inc.
New York In-Lieu Fee Program
LRB-2010-00673 (ILFP)

Date: 23 June 2021

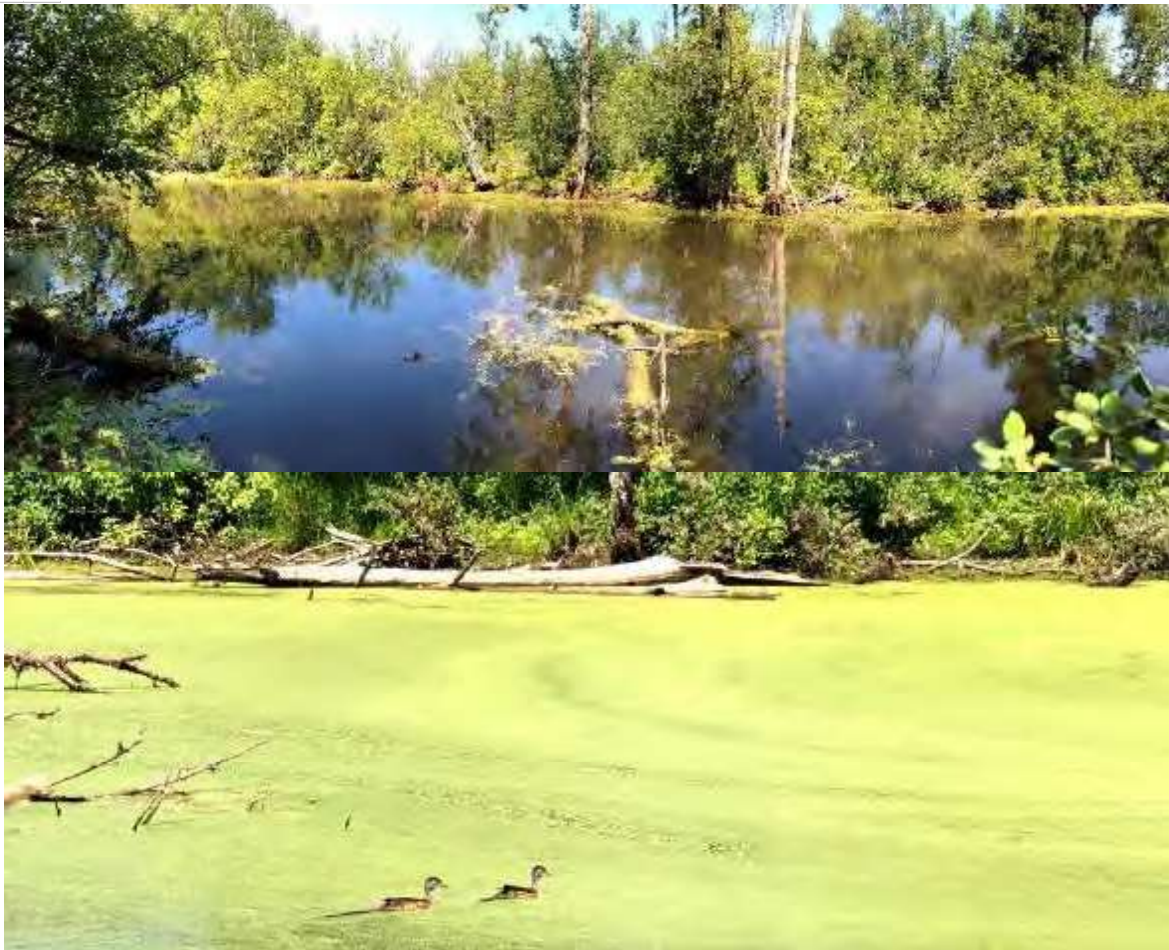
P-1 (Pond) Existing ponds on site are being used by waterfowl such as the juvenal wood ducks pictured.

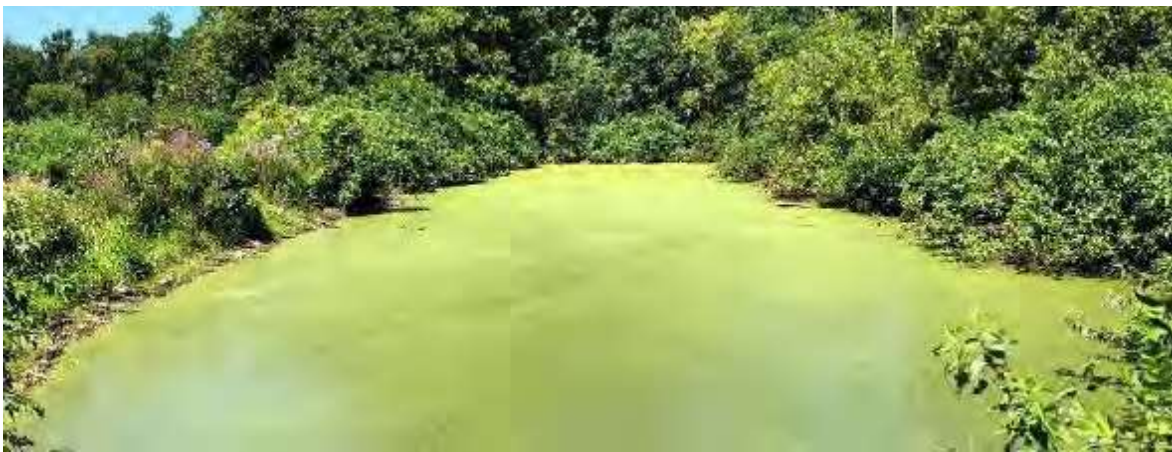
P-2 (Pond) Appears to be a manmade pond established sometime in the 1970's. Similarly, waterfowl have been frequenting this pond.

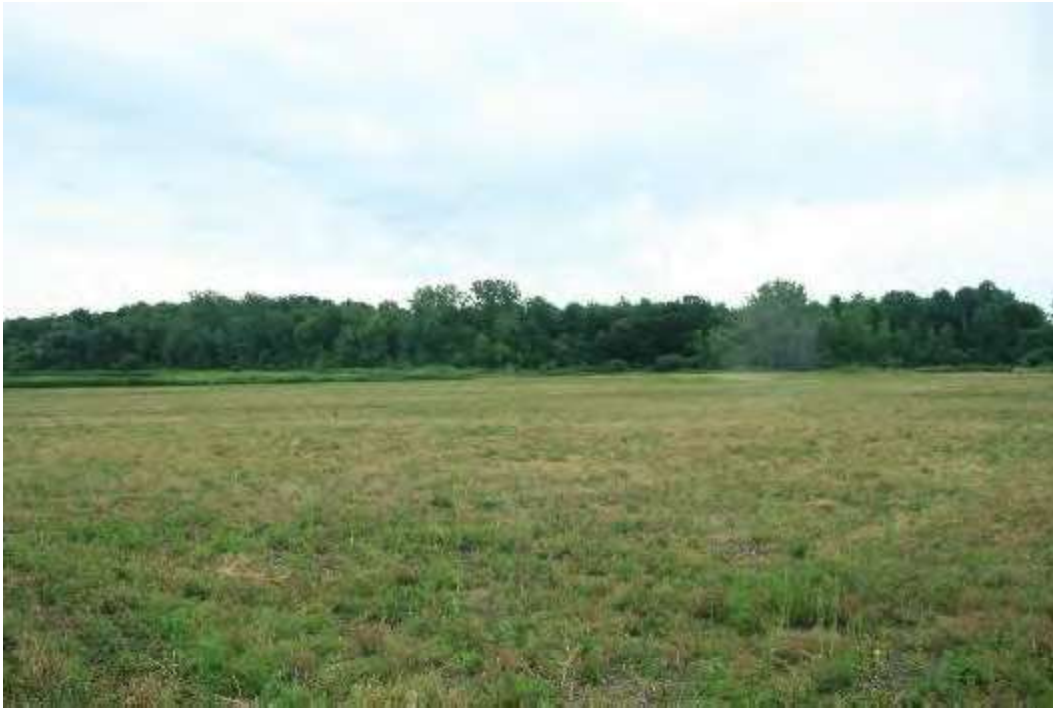
Conditions at the Site in July 2020. The site was mowed to facilitate topographic survey.

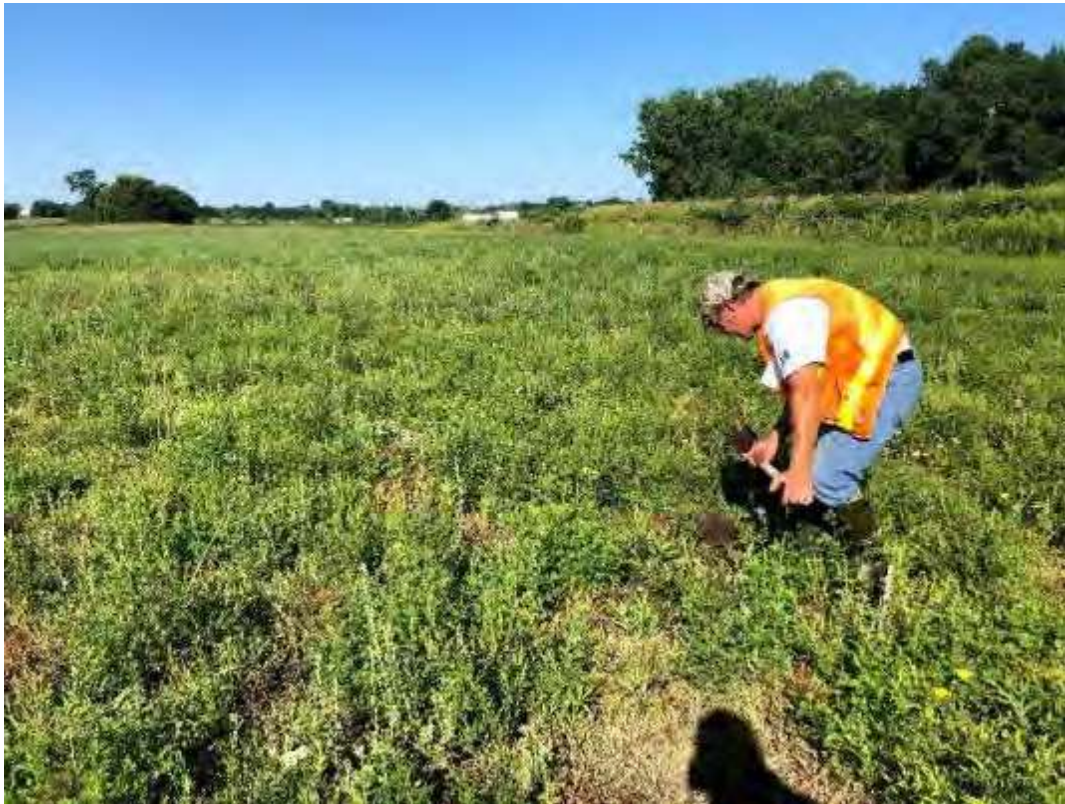
DPU1. This area was dominated by white clover (*Trifolium repens*) and large barnyard grass (*Echinochloa crus-galli*).

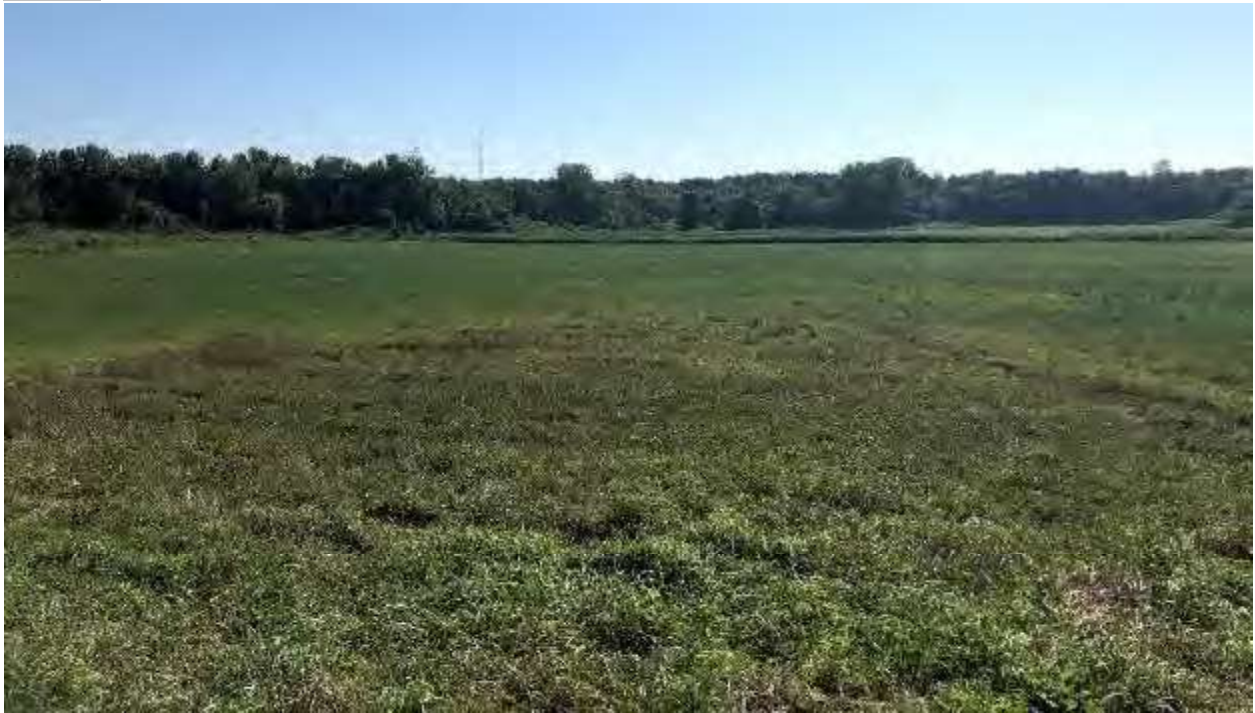
DPU2. This area was dominated by English plantain (*Plantago lanceolata*).

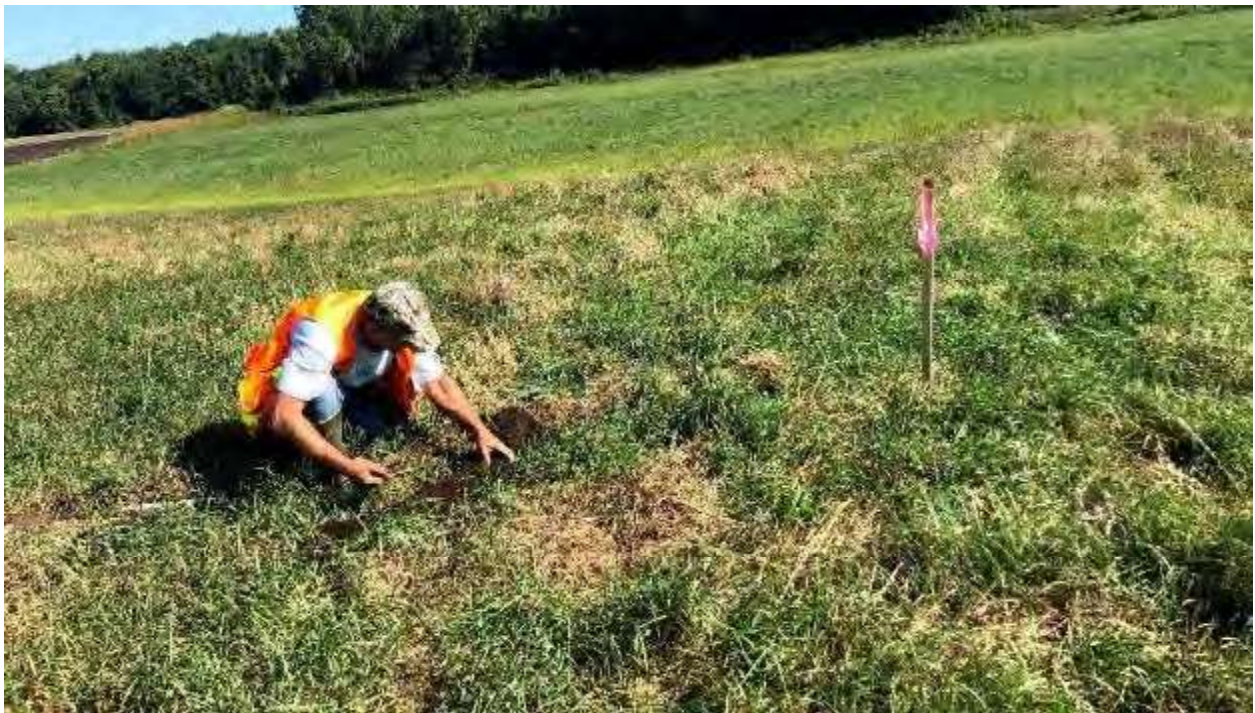
DPU3. This area was dominated by English plantain *Chenopodium album*, *Portulaca oleracea*, and *Ambrosia artemesifolia*. All FAC-U species.

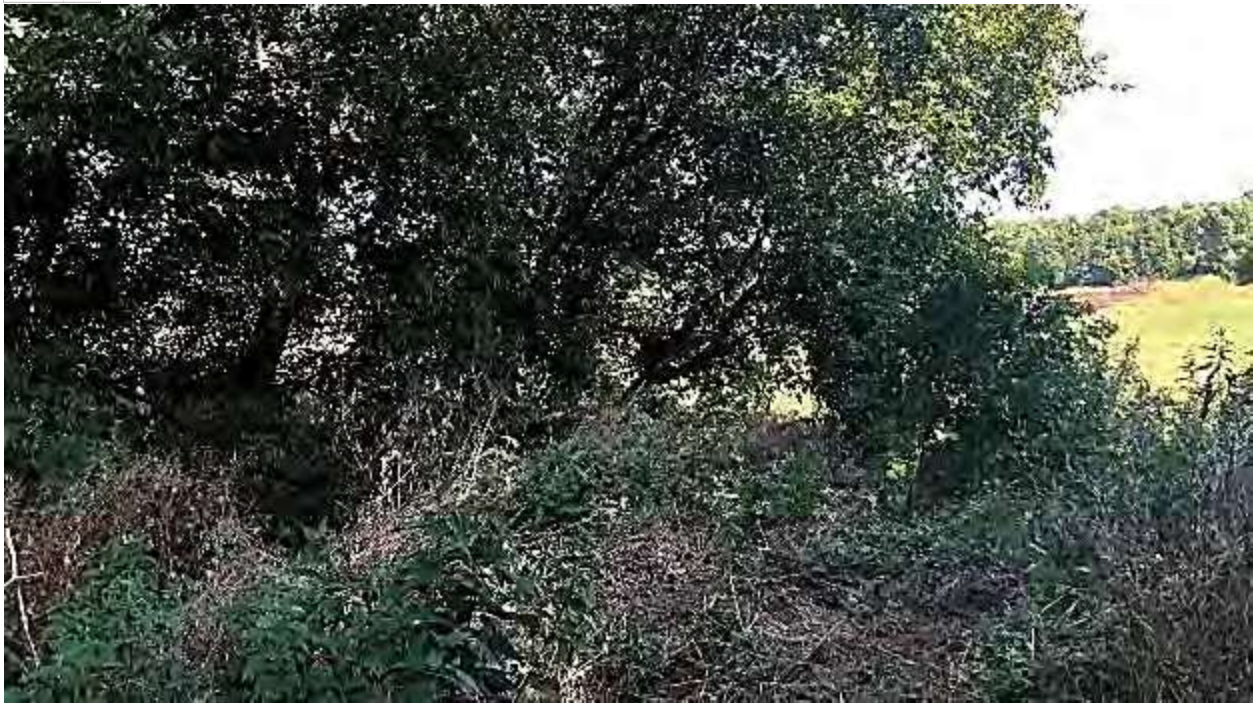
DPU4. A forested knoll with *Rubus pensilvanicus*, *Allaria petiolate* as the dominants with *Acer negundo* and *Populus deltoides* as the tree species present. Soils were dry and well-drained.

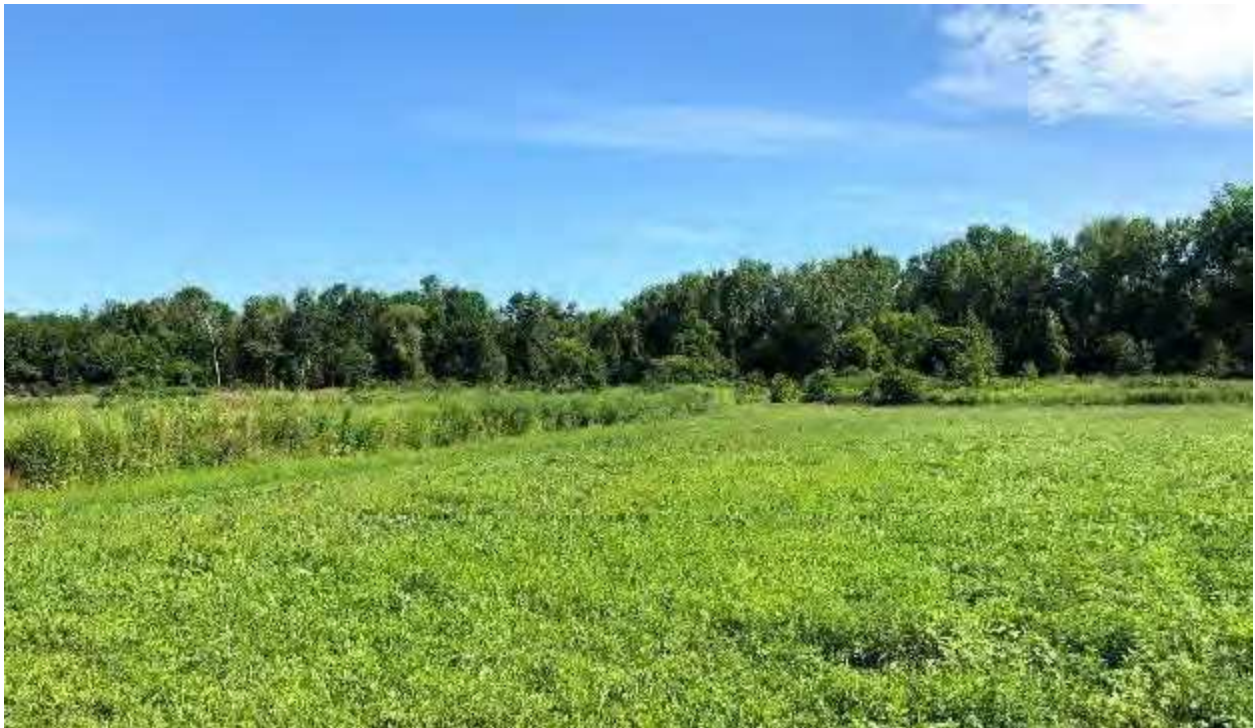
DPU5. This area was dominated by red clover (*Trifolium pratense*) and English plantain (*Plantago lanceolata*).

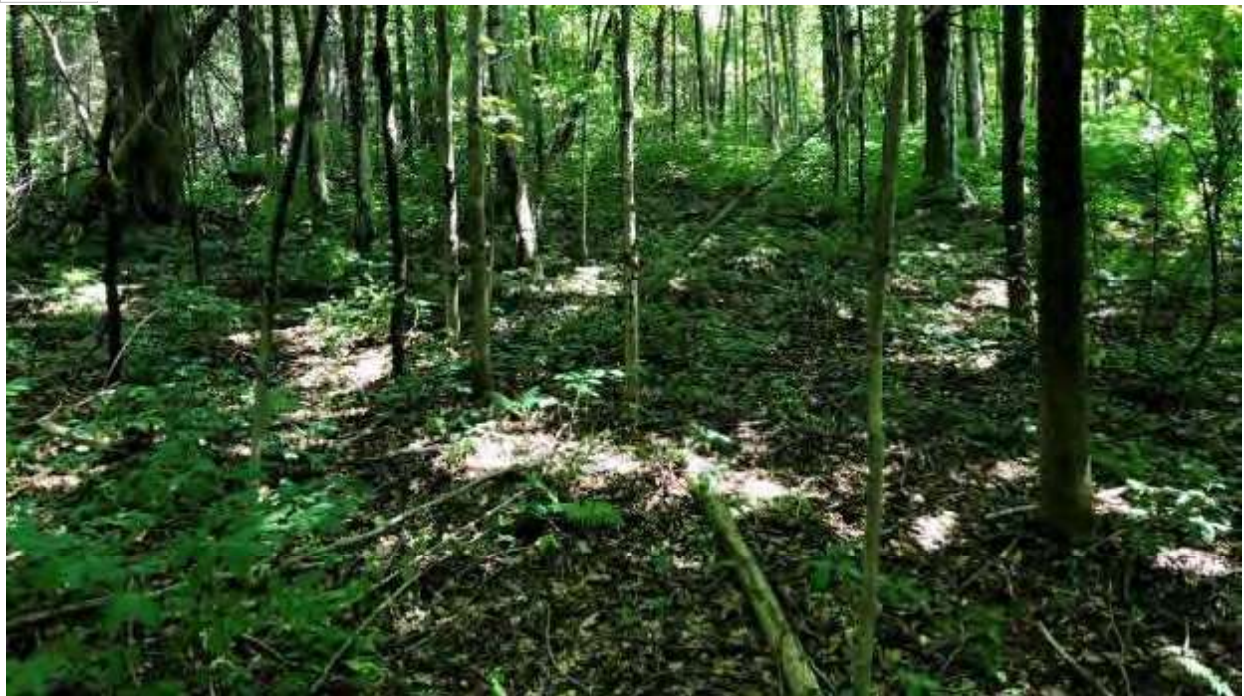
DPU6. This was a well-drained upland with black cherry and sugar maple as the dominant trees.

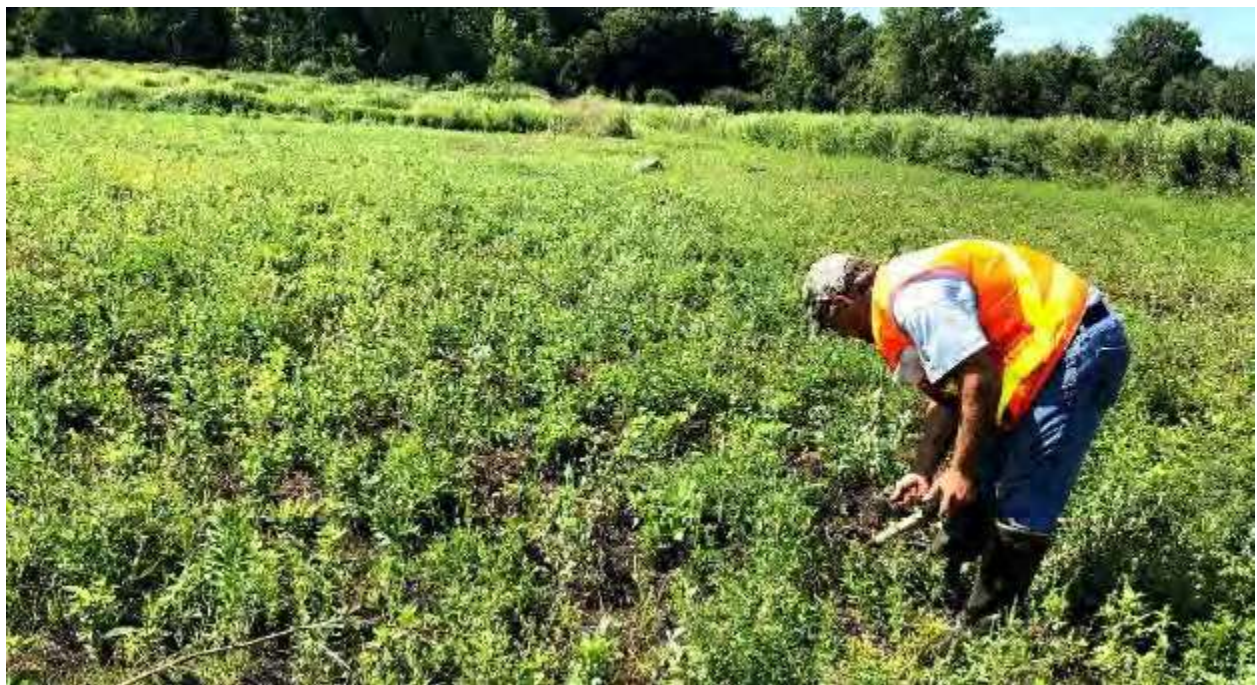
DPU7. This area was dominated by Canadian thistle (*Cirsium arvense*), perennial ragweed (*Ambrosia psilostachya*), prickly comfrey (*Symphytum asperum*), and common dandelion (*Taraxacum officinale*).

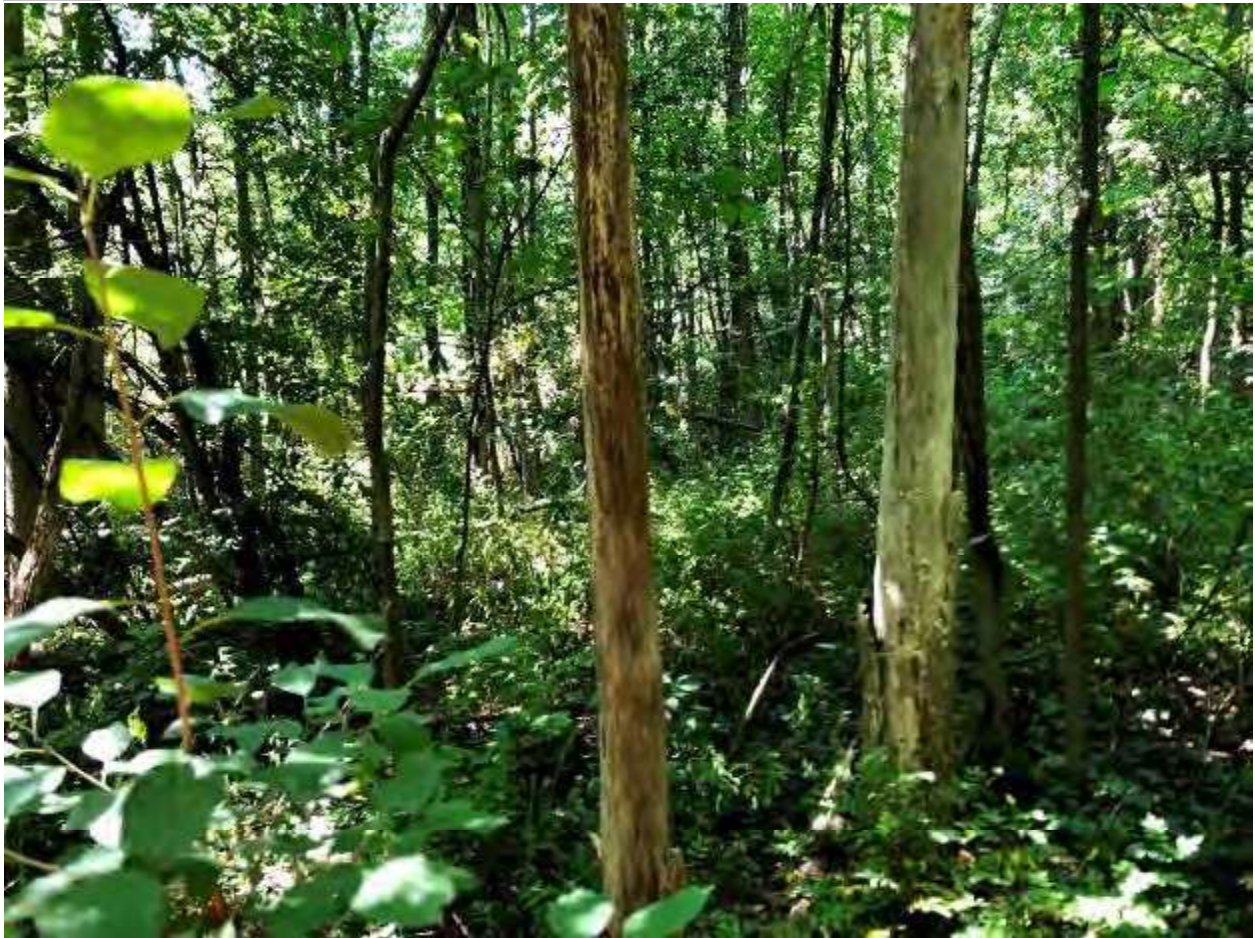
DPU8. Dominated by multiflora rose, bush honeysuckle and poison ivy in the understory. American elm, and sugar maple were dominants in the overstory.

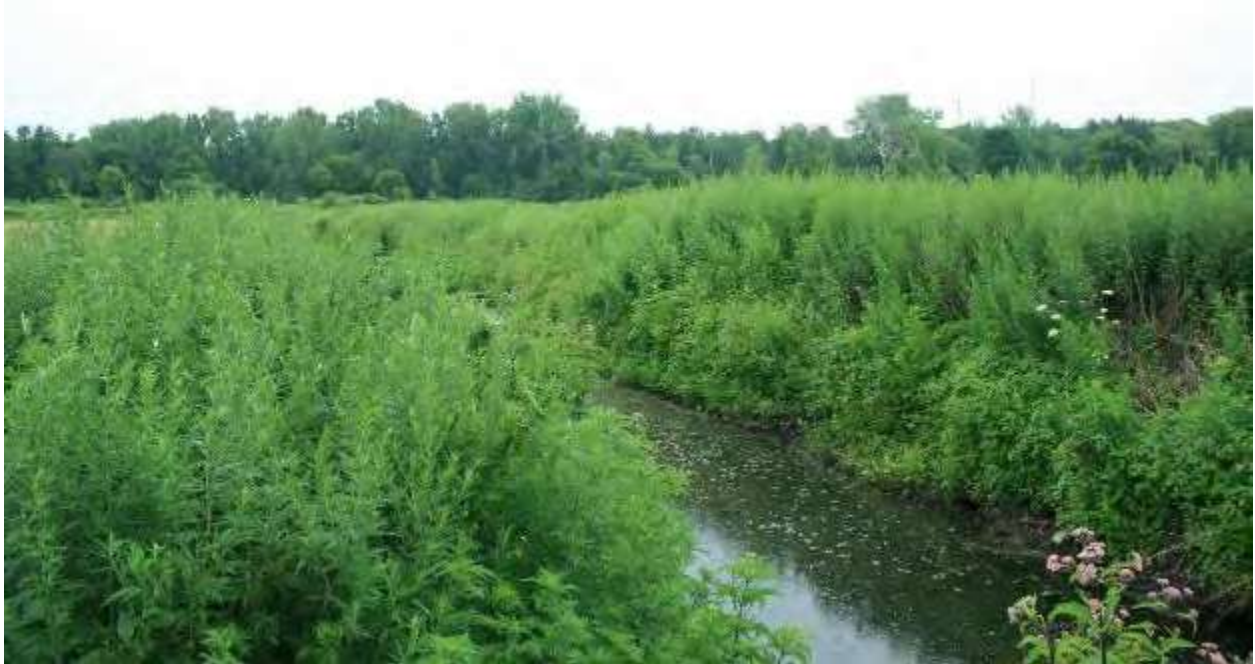
View of Snake Creek (S-1) in the interior of the property on July 21, 2020 Flow direction is South to North, the stream has consistently had standing water in all site visits.

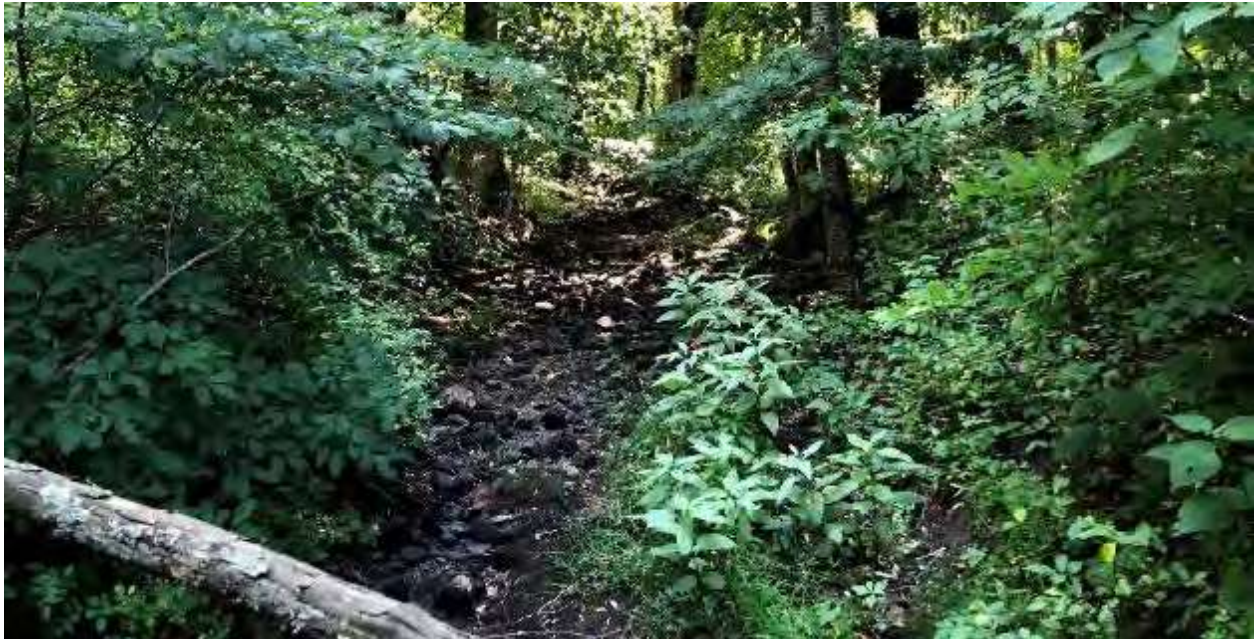
S-2 is a tributary to Snake Creek that originates offsite within in W-F shown in this image taken on August 14, 2020. S-2 appears to have seasonally intermittent flow and flows from Southeast to Northwest.

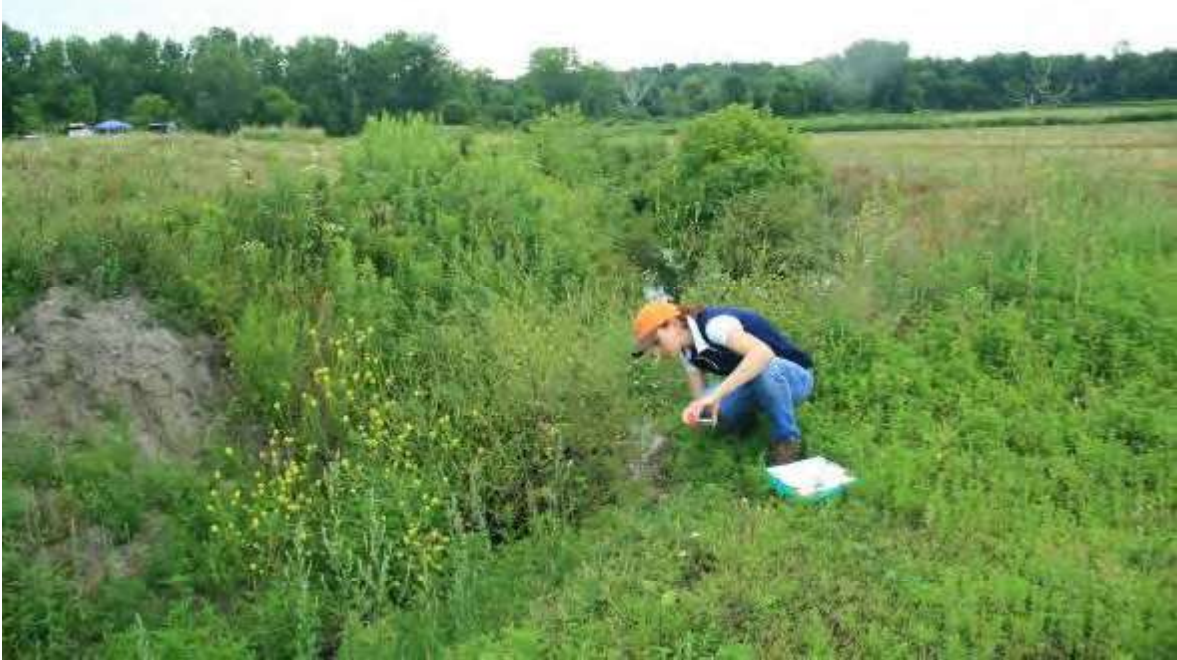
D-1 has steady standing water present. This view is looking West to East in the direction of flow. This ditch intercepts Snake Creek. DU Engineer Tamara Jameson examines soil conditions along the margin of the ditch. DU has proposed to pull back the side slope to the south (righthand side of image) to reduce the chance ditch sloughing.

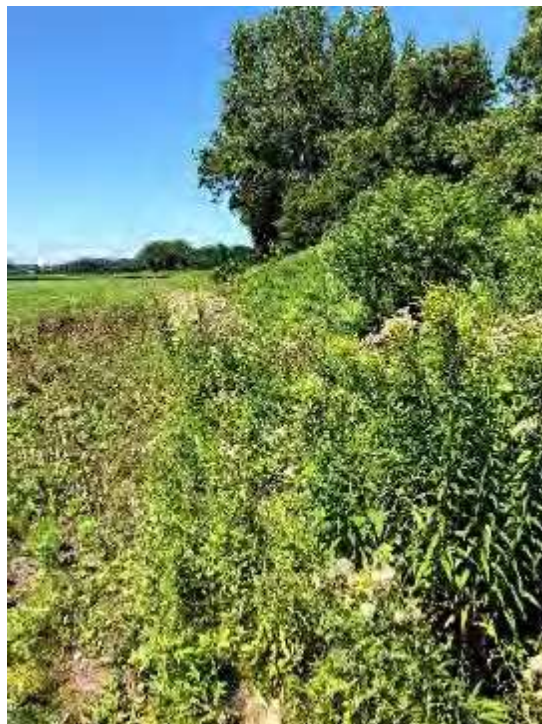
D-2 is a shallow interior ditch that appears to carry water from tile lines to Snake Creek. This ditch has been obscured by vegetation Joe-pye weed, (*Eutrochium maculatum*) and other hydrophytes during site visits.

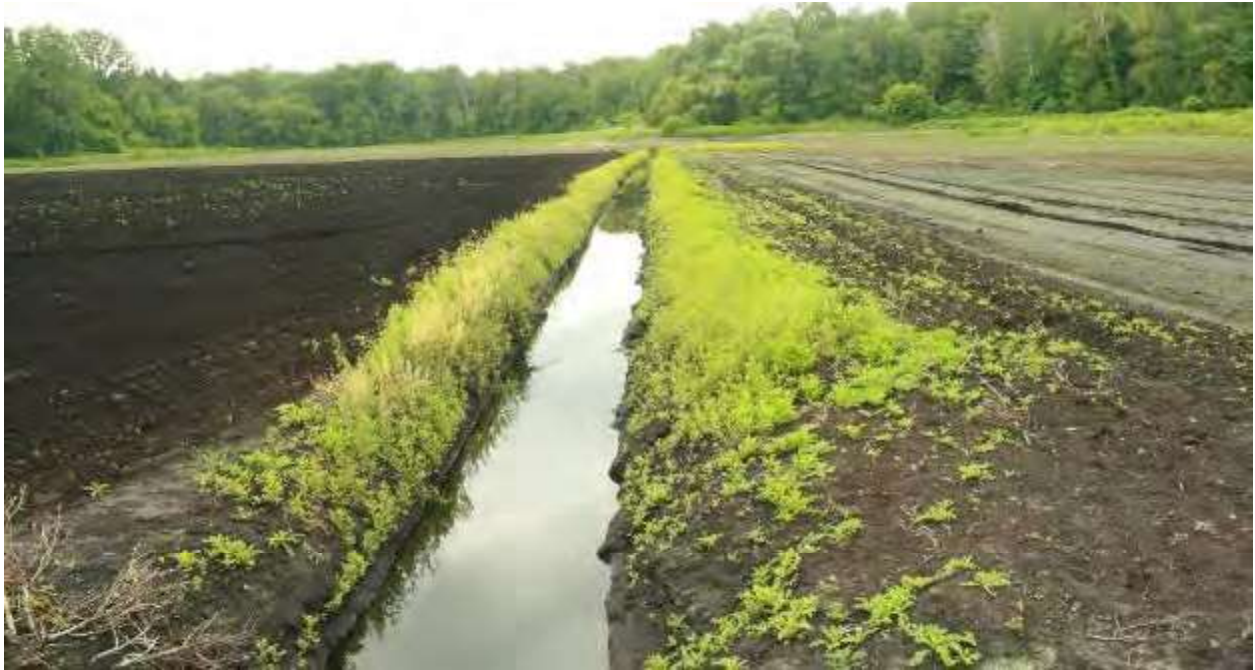
D-3 is a shallow interior ditch that carries water to Snake Creek, water outlets through a culvert into Snake Creek. It is approximately 2 feet deep. Here pictured after a heavy rain event in July 2019 while the site was still being tilled and farmed. Flow is from SE to NW into Snake Creek.

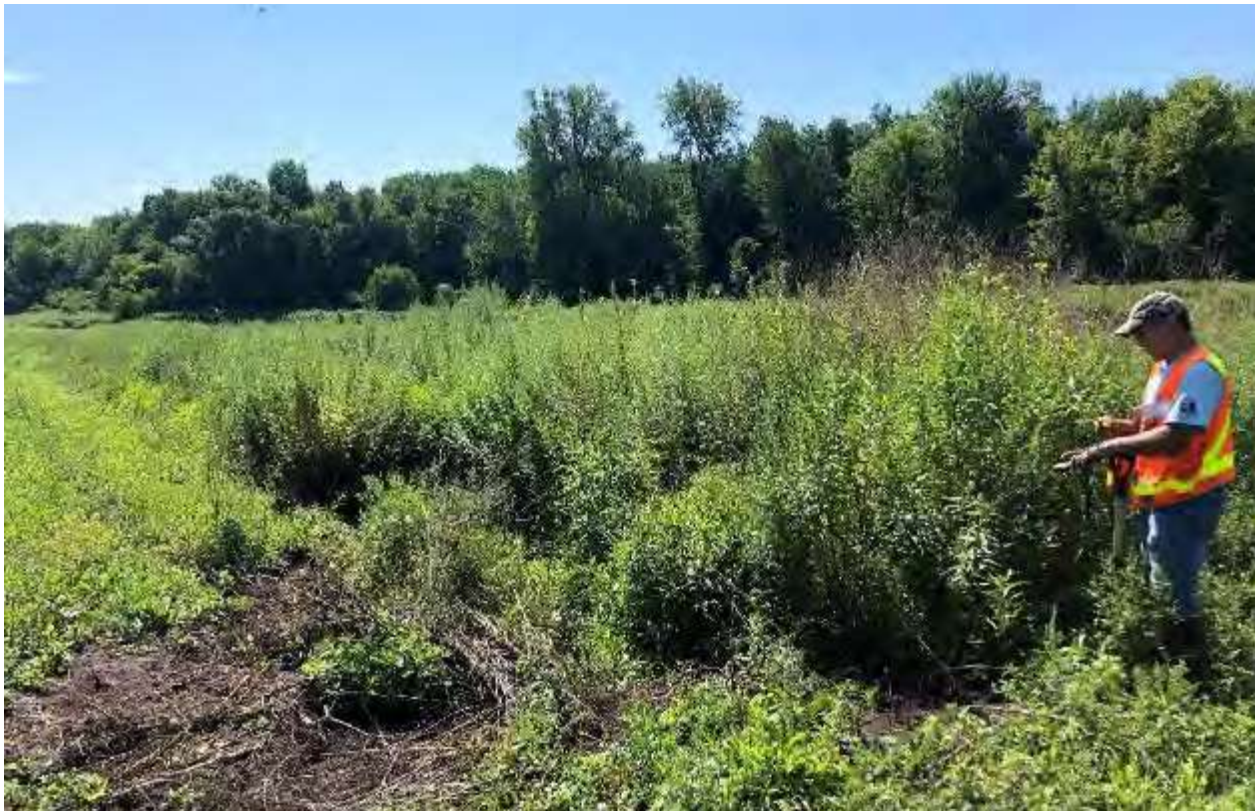
D-4 is a shallow interior ditch that carries water to Snake Creek, water outlets through a culvert into Snake Creek. It is approximately 2 feet deep.

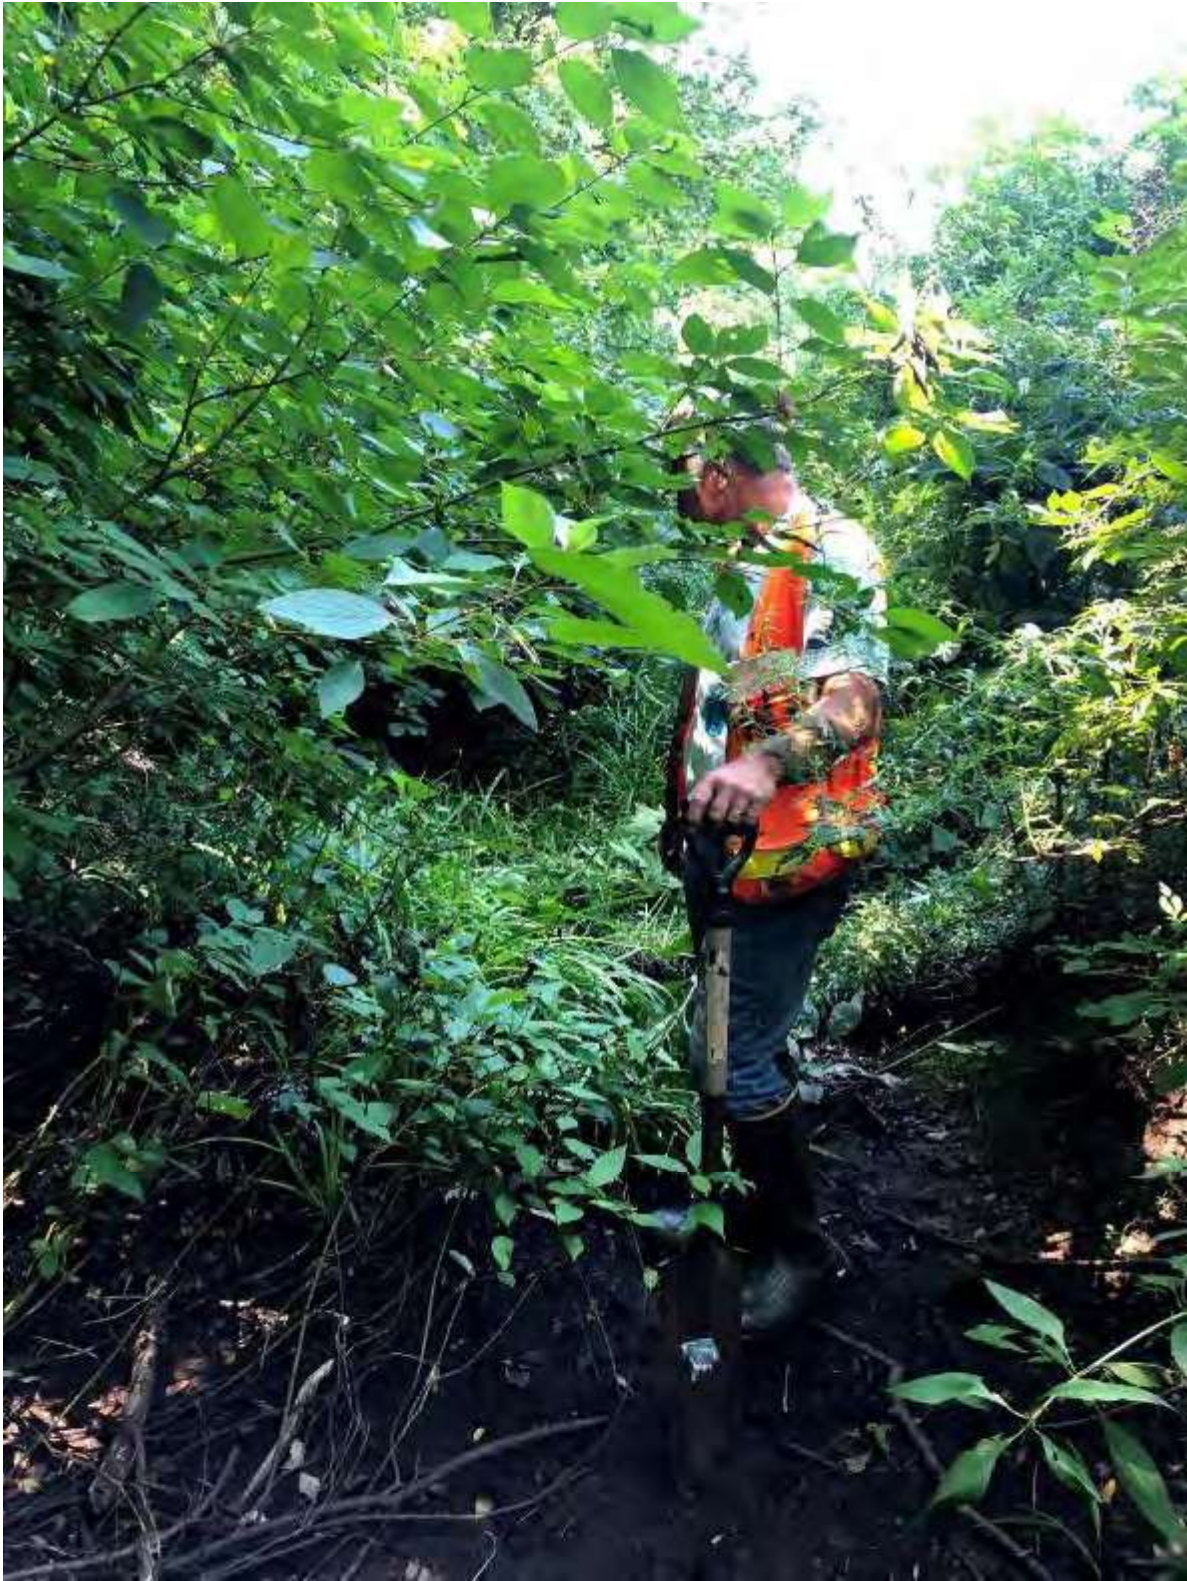
D-5 is a perimeter ditch that carries stormwater to Snake Creek. John Fraser stands in the ditch on August 14, 2021.

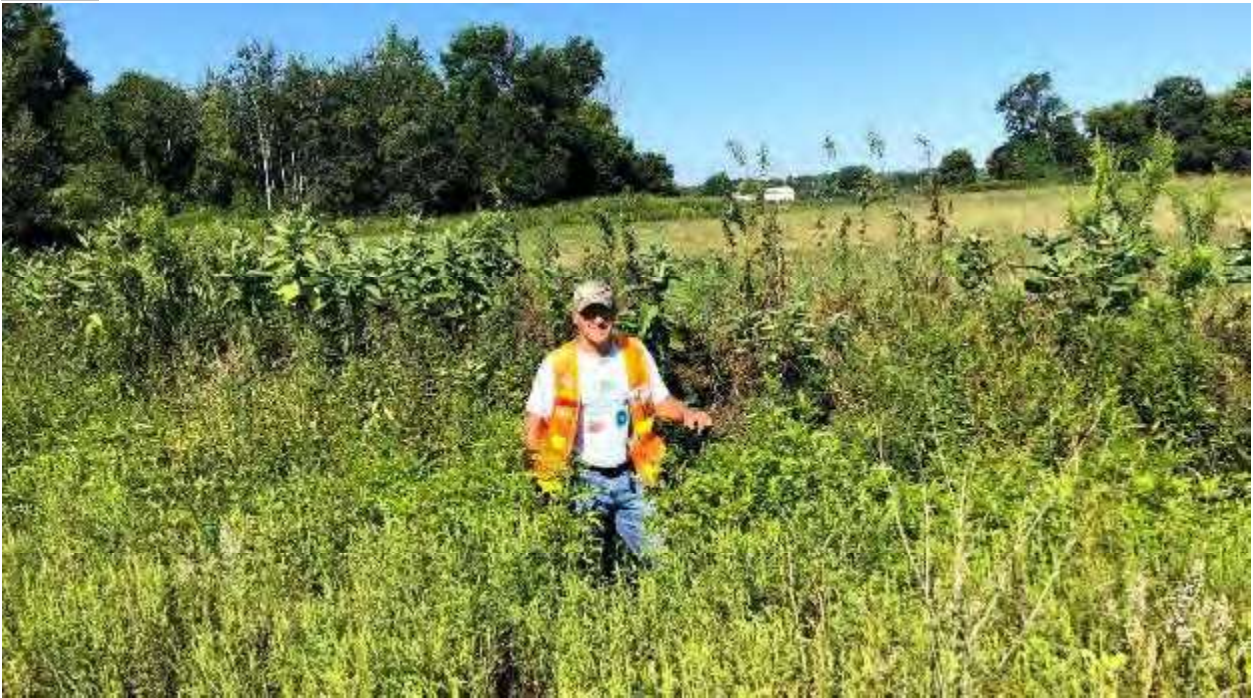
D-6 DU biologist John Fraser stands in the shallow interior ditch that is roughly 2-feet deep. August 14, 2020. D-6 appears to carry water to Snake Creek during precipitation events.

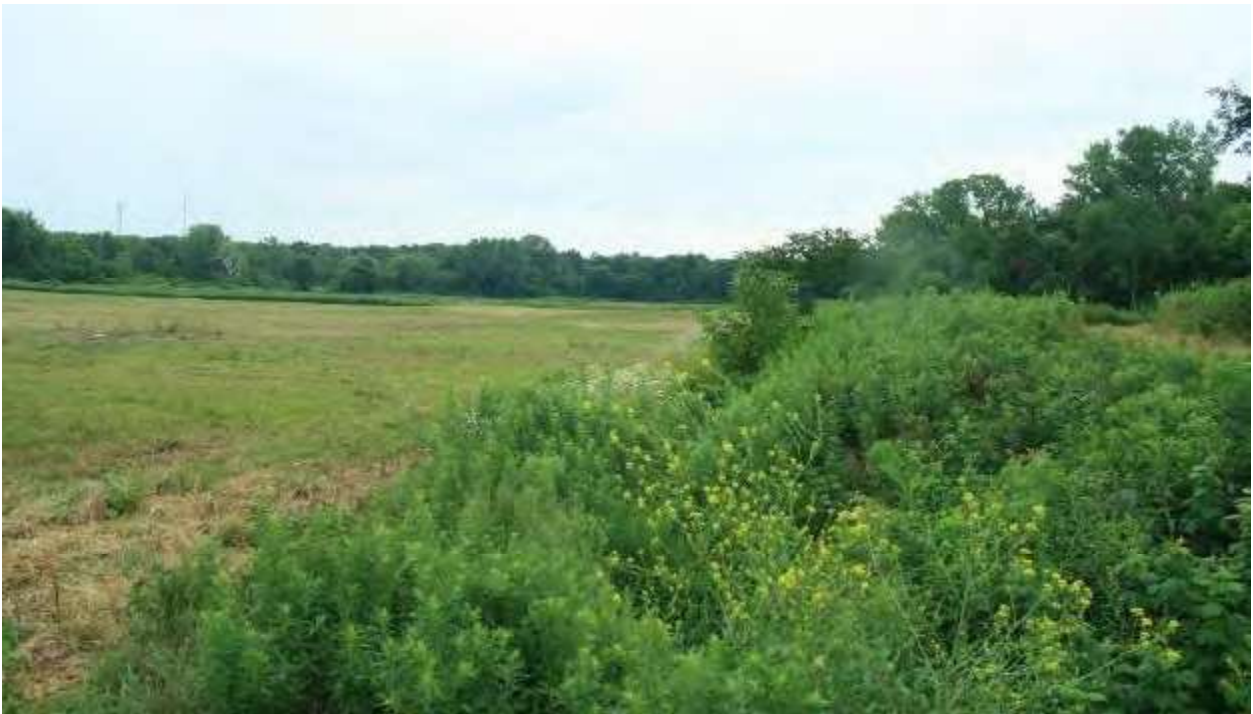
D-7 Is a shallow surficial ditch that carries overland flow during precipitation events to Snake Creek. Pictured August 14, 2020.

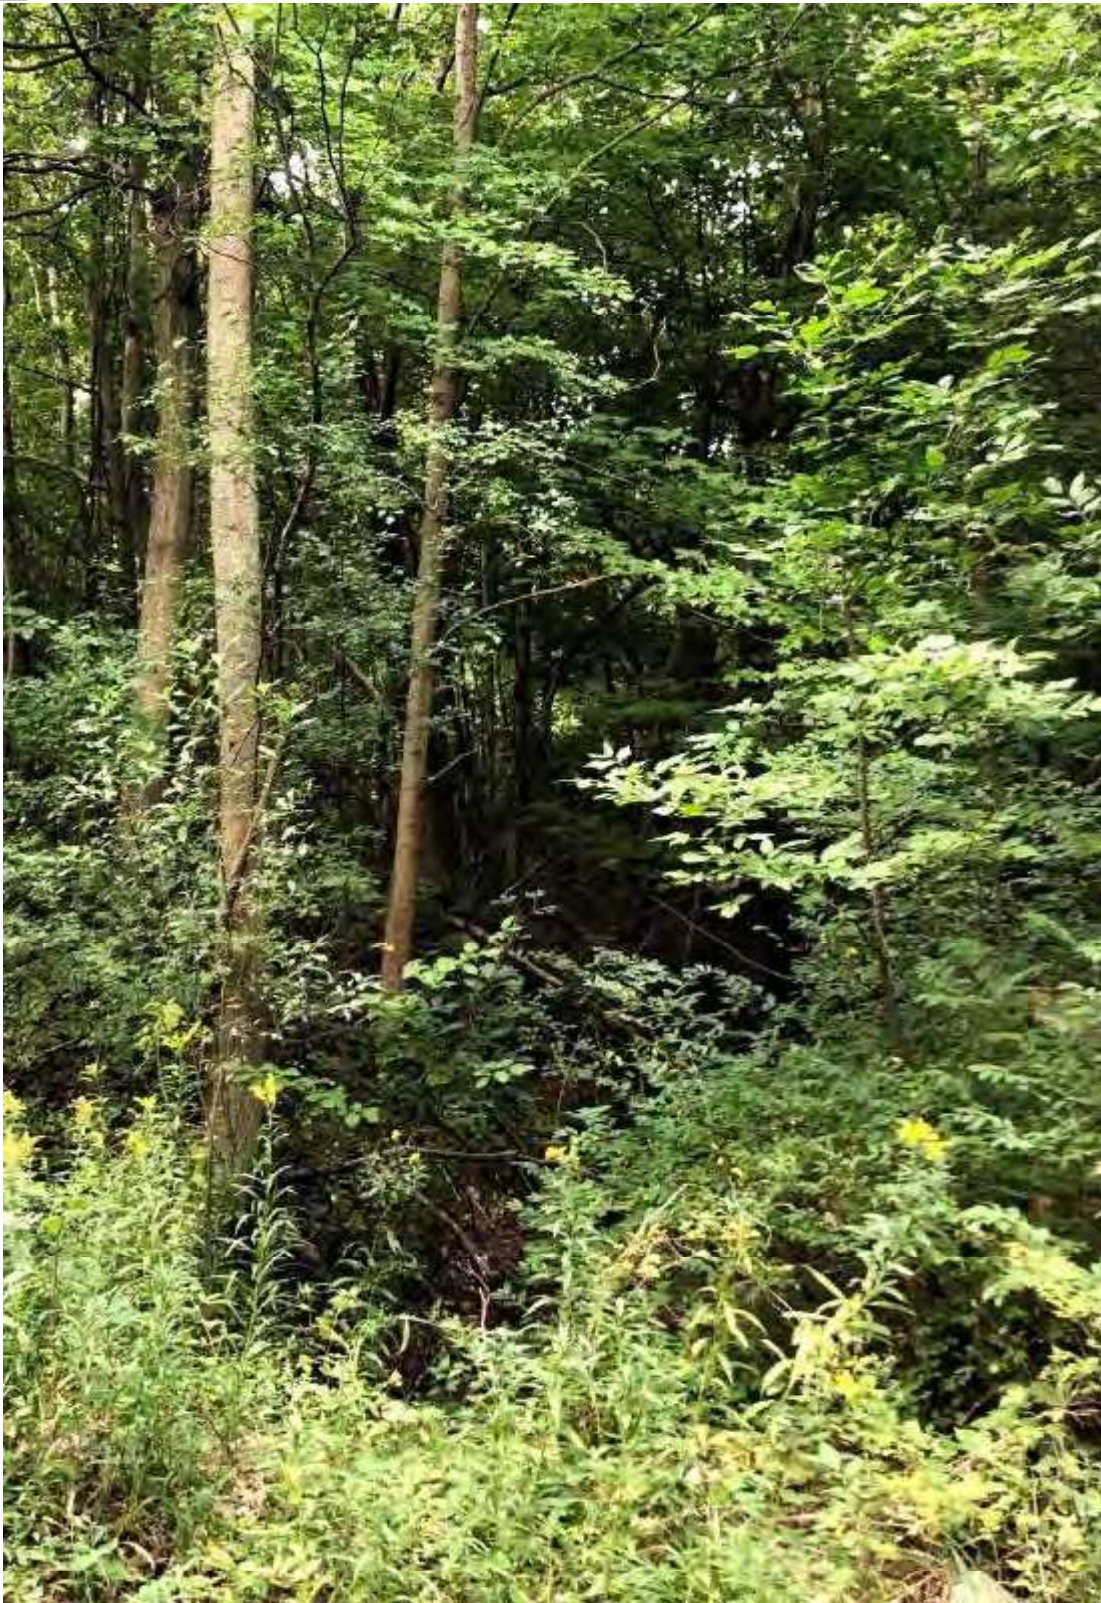
D-8 Is an old ditch that carries water from an adjacent agricultural field to Snake Creek. It flows from West to East. This ditch is along the northern property boundary.

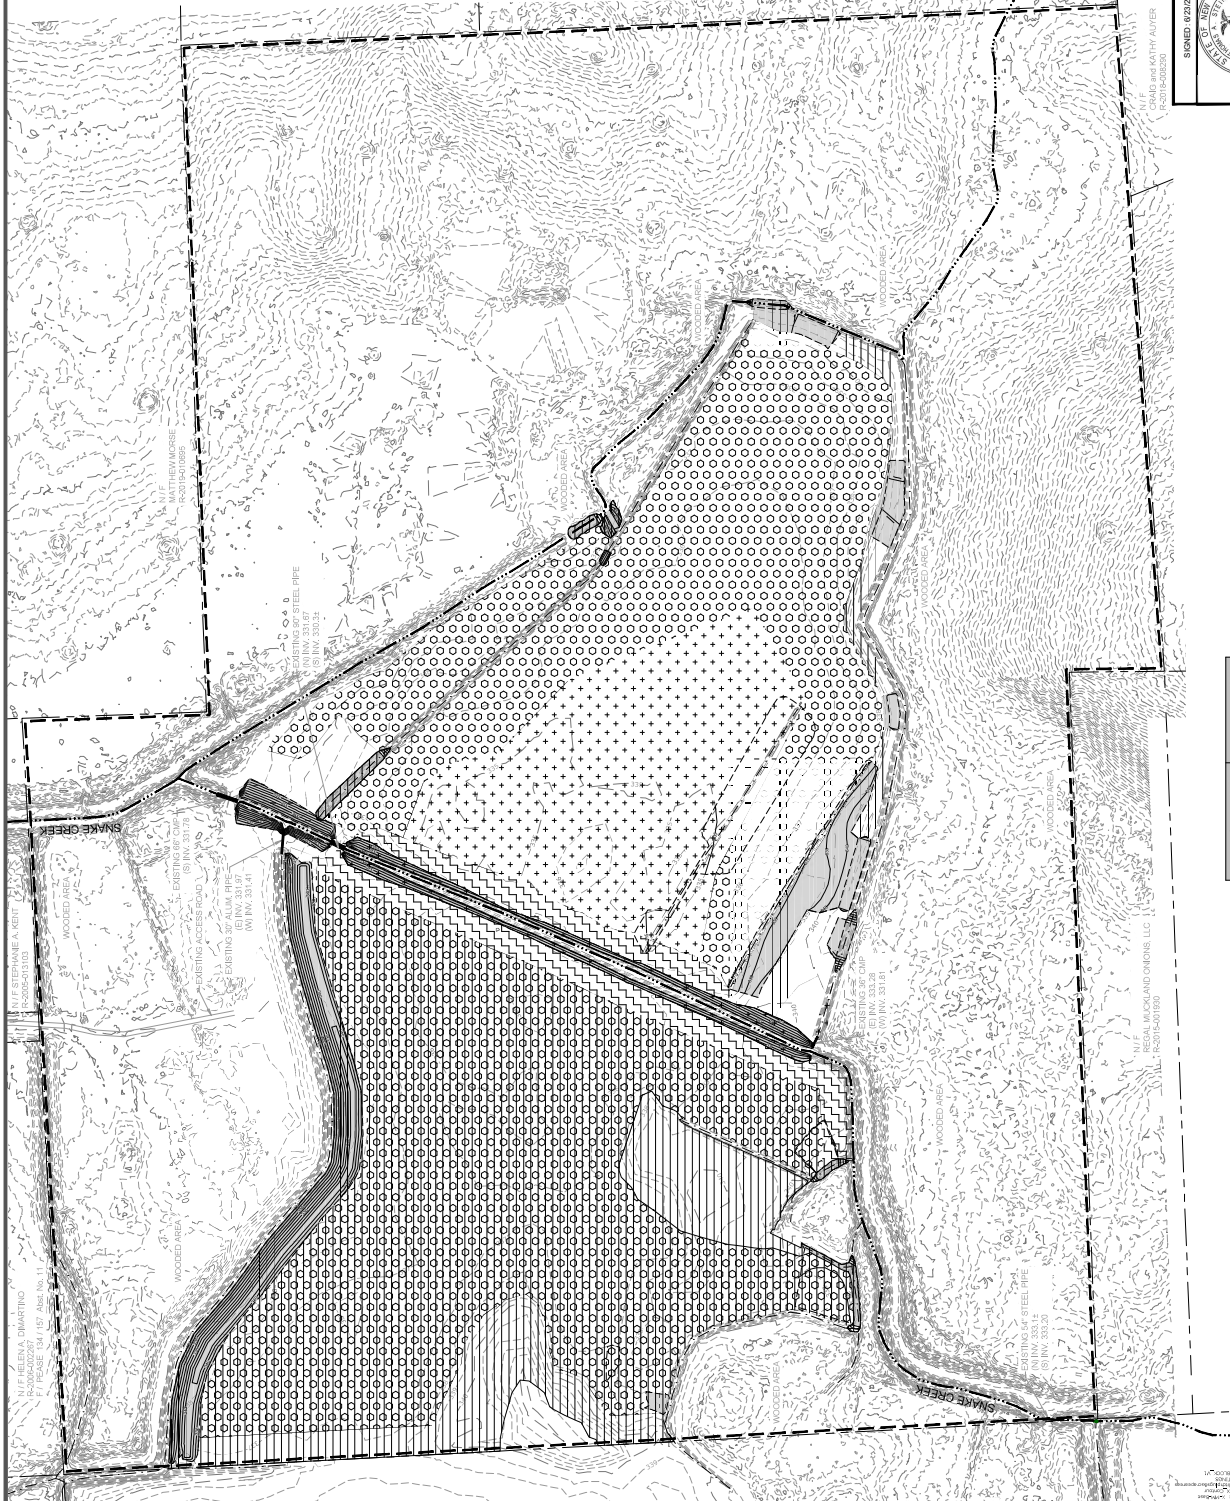
SEED MIXES/ TREE PLANTINGS

Target Use	Plant Species Common Name	Plant Species Scientific Name	Vegetation Associates Status	Percent Composition by Weight/Seeds per Acre	Propagula Type	Quantity/Acre
Wetland Seed Mix	For Sedge	<i>Carex lasiocarpa</i>	OB	25%		
	Virginia wild rice	<i>Echinochloa virginica</i>	FACW	15%		
	Lund Sedge	<i>Carex lasiocarpa</i>	OB	10%		
	Knapgrass	<i>Glycerhiza canadensis</i>	OB	5%		
	Bluejoint Grass	<i>Calamagrostis canadensis</i>	OB	5%		
	Broom Sedge	<i>Carex scoparia</i>	FACW	5%		
	Hop Sedge	<i>Carex lupulina</i>	OB	5%		
	Soft rush	<i>Juncus effusus</i>	OB	4%		
	Spotted Joe pye	<i>Eutrochium maculatum</i>	OB	4%		
	Blue vervain	<i>Verbena hastata</i>	FACW	3%		
	Bar Reed	<i>Sagittaria arifolia</i>	OB	2%		
	Eastern Bur. Reed	<i>Sagittaria arifolia</i>	OB	2%		
	Nodding bur	<i>Sagittaria arifolia</i>	OB	2%		
	Woods	<i>Sagittaria arifolia</i>	OB	2%		
	Swamp milkweed	<i>Asclepias incarnata</i>	OB	2%		
PFO	Silver maple	<i>Acer saccharum</i>	FAC	25
